Installation of Radvantage system

Combined waterproofing and radon gas management system for basement conversion project in Bath

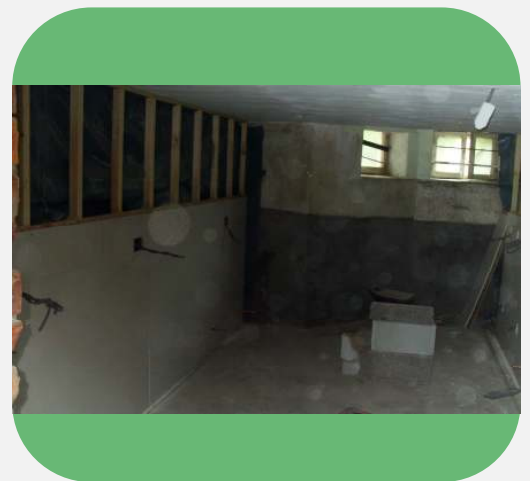
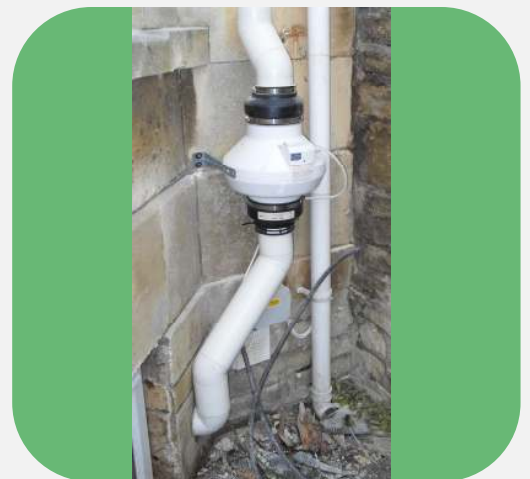
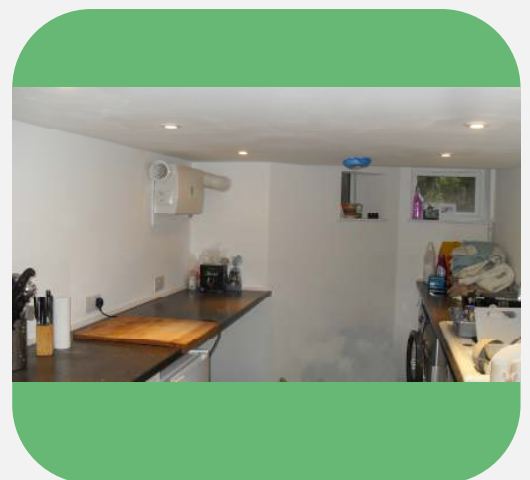
propertECO surveyed the property and recommended the installation of the Radvantage system. Using a combination of cavity drainage membrane and air management, radon gas can be collected behind the membrane and vented safely away from the property. This system ensures that radon is not simply diverted to other parts of the building and also provides a dry surface.

After the membrane and air management units had been installed, the client was able to fit out the cellar to their chosen specification.
